# Cost and Performance Report

(WP-200528)

## Zero VOC, Coal Tar Free Splash Zone Coating (SZC)

September 2011

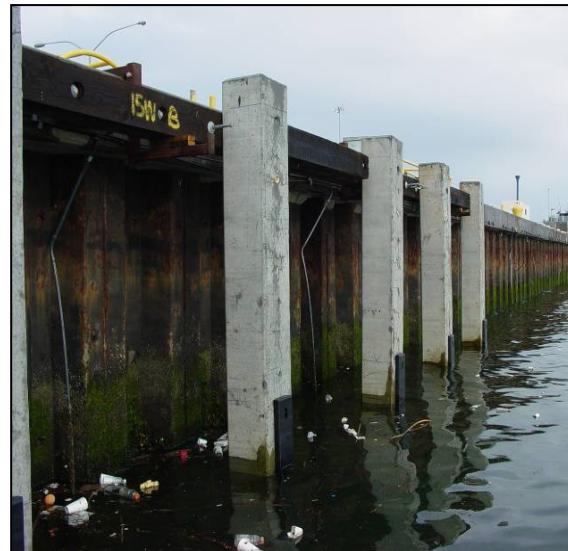
**Figure 4. Demonstration site at NAVSTA San Diego before coating application.**

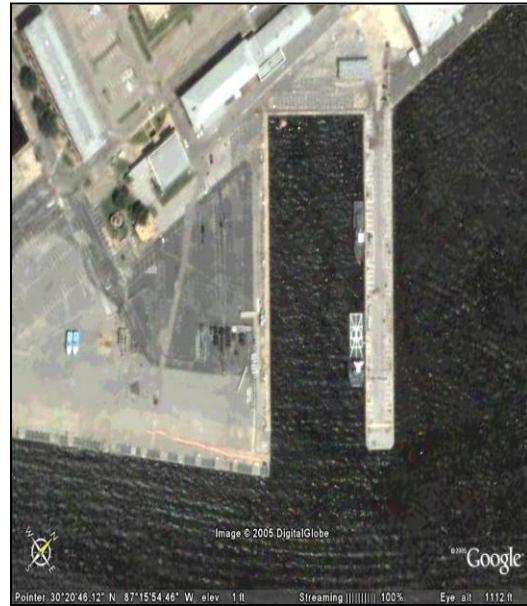
**Figure 6. Bulkhead 303 Pensacola.**

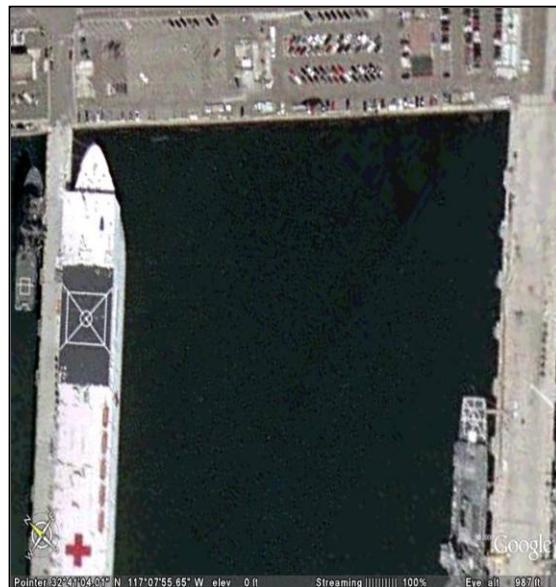
**Figure 8. Quay wall between Piers 1 and 2, San Diego.**

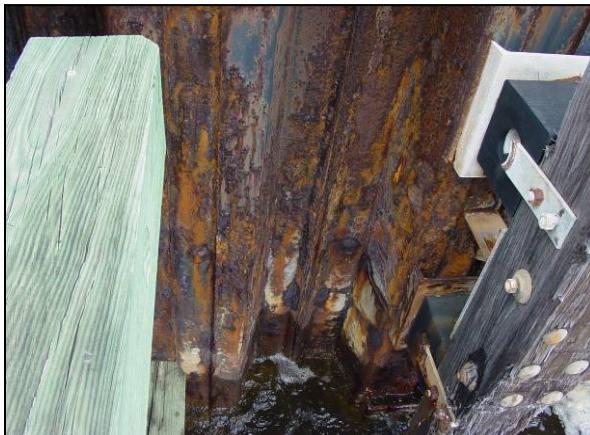
**Figure 9. Typical corrosion on Pensacola steel sheet pile before surface preparation.**

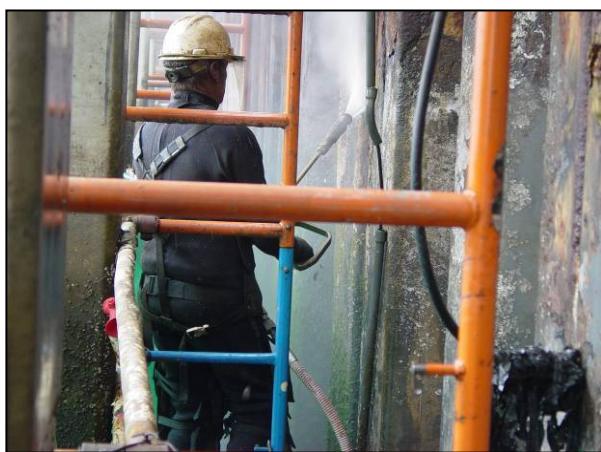
**Figure 12. San Diego steel sheet pile surface preparation.**
